MEMORANDUM

Project No.: AS240155

May 29, 2024

Re: **Manastash Creek Channel Migration Zone Preliminary Evaluation, Ellensburg, Washington**

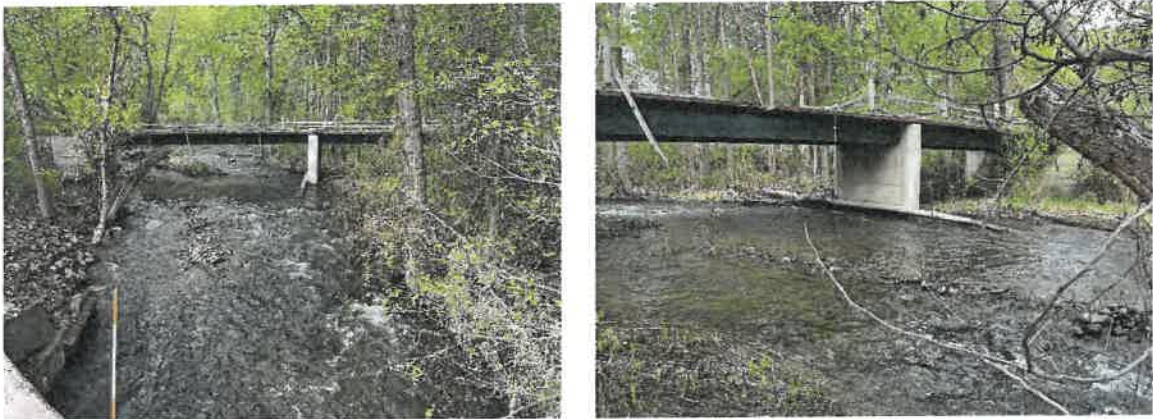
Project Area	Key Observations
Upstream	Adjacent upstream property has built a bridge within the past decade with concrete pier, abutments, and wing walls. Bridge appears in good condition. Creek is mostly linear with narrowing channel width towards property bridge. Gravel bars are present in channel. Alluvium comprised primarily of subangular to rounded basalt gravel and cobbles. Trace woody debris present in channel represented by log against the neighboring bridge pier. Cottonwood trees, grass, and low brush vegetation grow on both banks

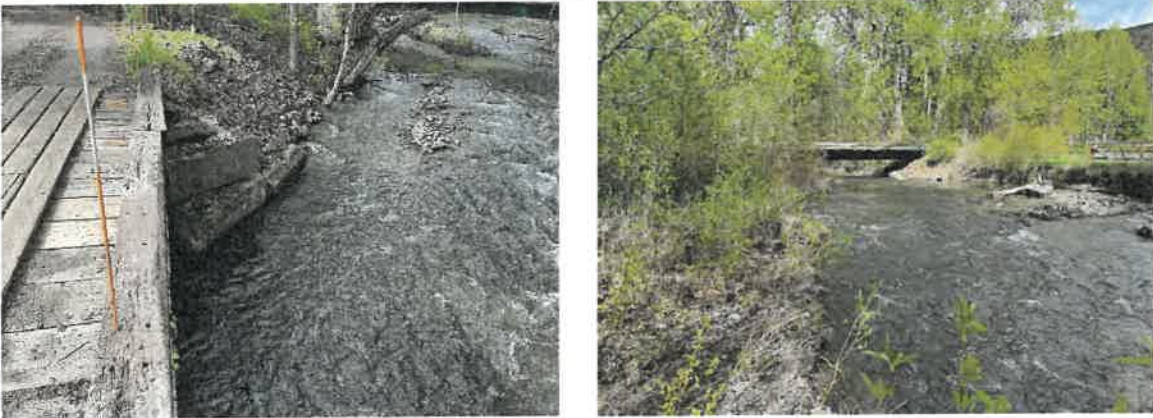
Bridge Over Creek at Subject Property	Creek channel constrained below bridge by ecology block walls on both banks. Ecology blocks are locally in poor condition with a right bank abutment slightly bulging toward the creek. Right bank armored upstream of ecology block wall protects the south bridge approach. Banks are not armored downstream of bridge, with visible erosion on left bank approximately 40 feet downstream of the bridge. No woody debris in the channel is observed upstream, with few woody debris tree stumps in channel near left bank downstream.
