GG Environmental, LLC

RE: Wetland and Stream Critical Areas Evaluation and Stream Buffer Mitigation Plan for the Construction of Two Single-family Residences on Kittitas County Parcels 20560 and 20561.

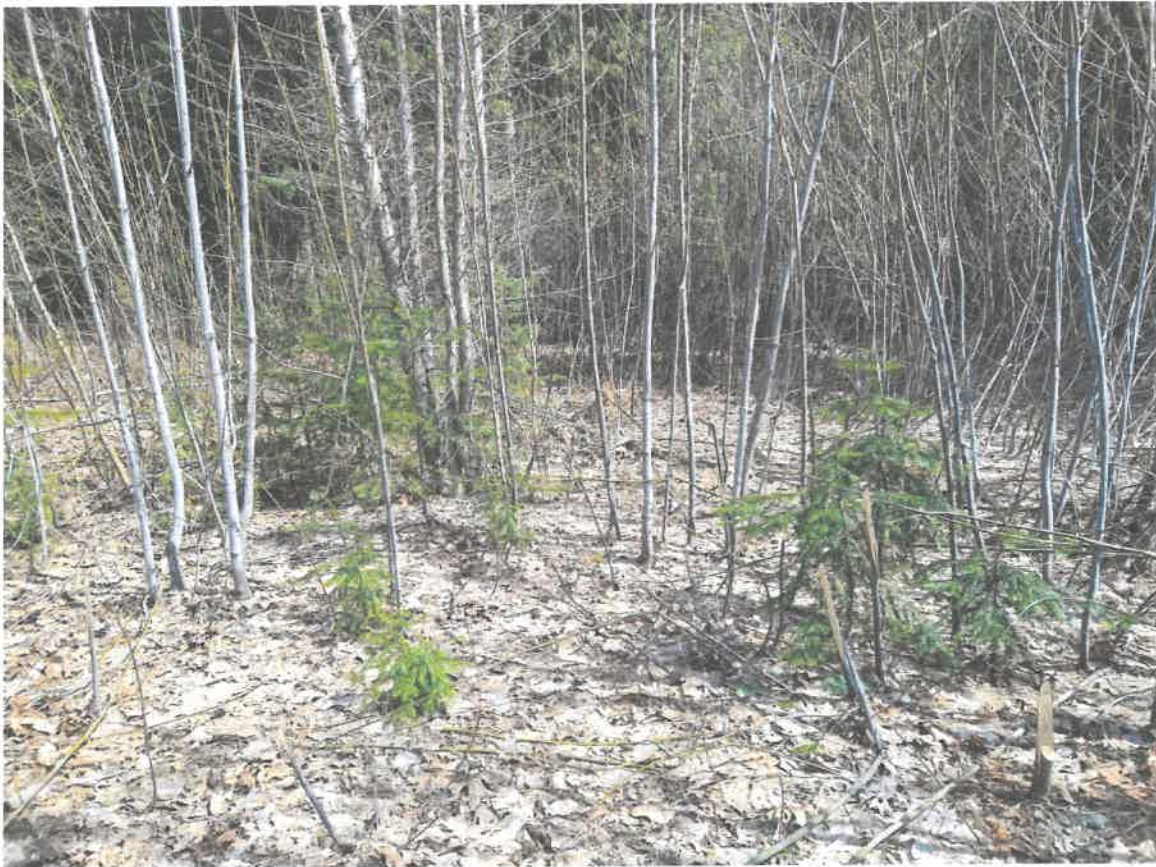
Figure 3. Typical upland vegetation (big-leaf maple, Douglas-fir) (April 12, 2024)

herbaceous vegetation is limited to scattered western trillium (*Trillium ovatum*). The only facultative (FAC) plant species observed was western red cedar (*Thuja plicata*) represented by a couple of large trees along the creek edge. No facultative wetland (FACW) or wetland-obligate (OBL) plants were noted.

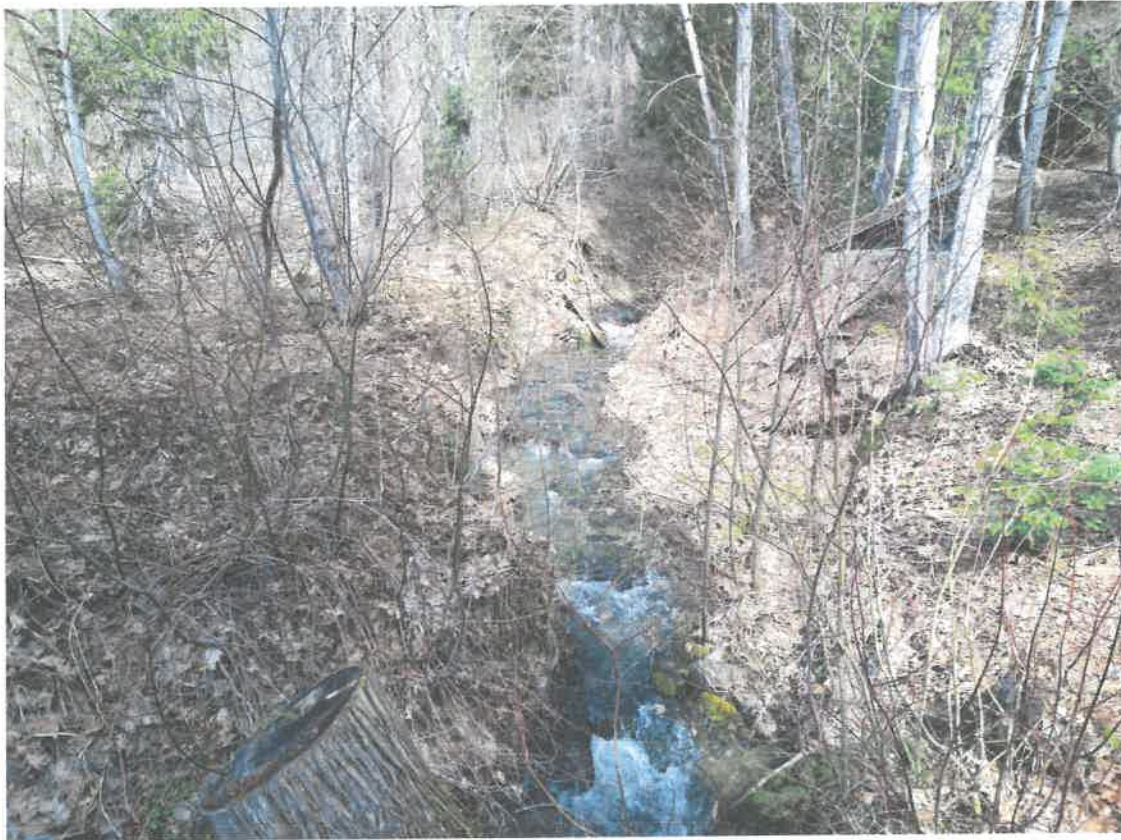
Figure 4. Spring Creek (view upstream from bridge) (April 12, 2024)

Hydrology observations: Spring Creek flows along the toe of a steep rocky slope. Significantly incised and well-vegetated along the banks (**Figure 4**), no evidence was observed to indicate that ordinary flows overtop the creek banks, even though wracked debris was observed at ~3.5 ft above the wetted width during the site visit.⁸ The creek channel exhibits steep banks with erosion and undercutting noted in several locations. High-velocity flows due to a relatively steep gradient have washed away fines, leaving a rocky, scoured bed largely devoid of vegetation. Given the elevated position of the PBA upon sandy substrate, no evidence of seasonally-elevated groundwater within the uppermost 12 in of the soil profile was observed, even at the lowest depression along the creek bank.
