**From:** [White, Lori \(FCY\)](#)  
**To:** [Kelly Bacon \(GD\)](#)  
**Cc:** [Lindsay Ozbohl](#)  
**Subject:** RE: SX-19-00018 - Daniels Wetland Biologist Report  
**Date:** Friday, December 6, 2019 1:25:12 PM  
**Attachments:** [image001.png](#)  
[image002.png](#)  
[image005.png](#)  
[image007.png](#)  
[image008.png](#)  
[image010.png](#)  
[image013.png](#)  
[image014.png](#)  
[image015.png](#)  
[image016.png](#)  
[image017.png](#)  
[image018.png](#)

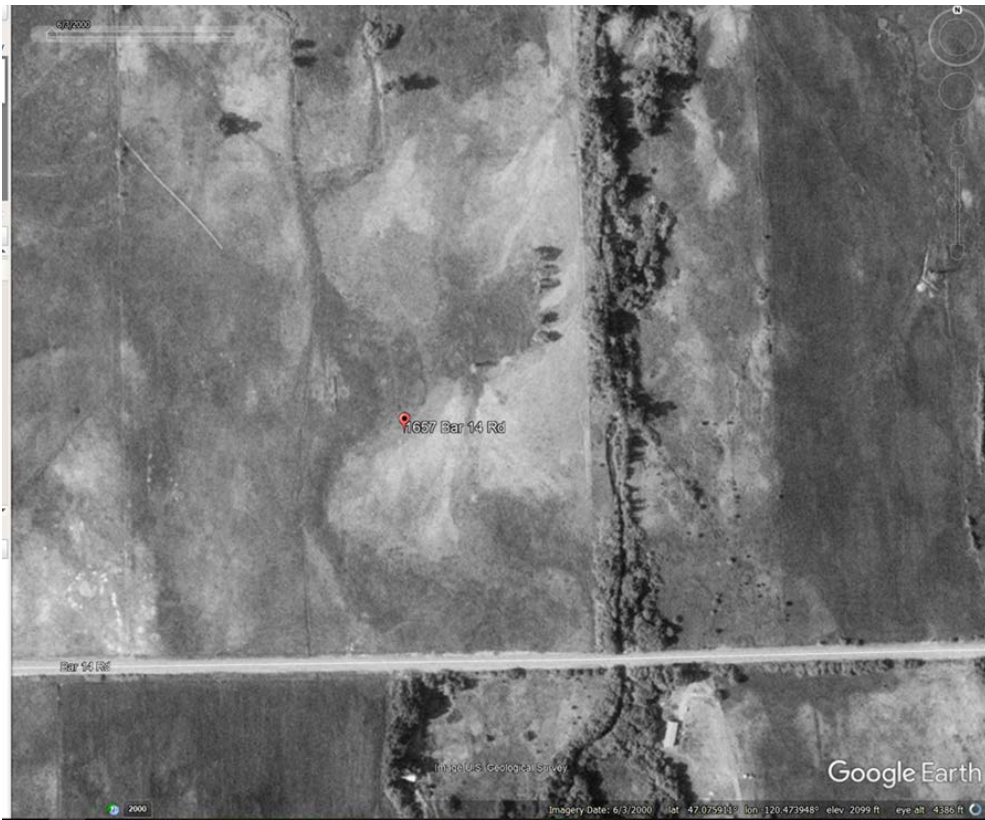
Image 2. 6/3/2000

I have reviewed Mr. Sewall's report and I am not convinced the wetland is from irrigation. Historical images from 1954 show the area to be connected to Naneum previously, and consisting of side channels (Image 1, 2, and 3; approximate area of interest is outlined in red). Topographic features or the old channels can be found in Lidar imagery (Image 4). It is currently located outside the Creek's floodplain. There is likely still some subsurface connection occurring, as the wetland appears to be part of a larger complex this should be evaluated further.
